# Manhole Inspection Summary

Manhole # S35M\_\_038MH

Insp Date: **3/24/08 9:32 AM**

**Location** Address: **John L Deaton Pavilion**

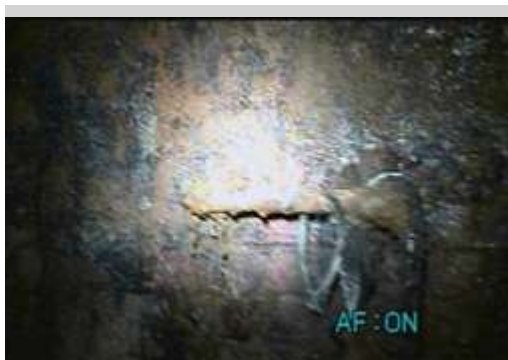
Defect 4

**Surcharge** ☒ **Evidence Of Surcharge** Depth: **24** (ft.) ☐ Active Surcharge Present

surcharge at 24 feet 2nd stop from bottom

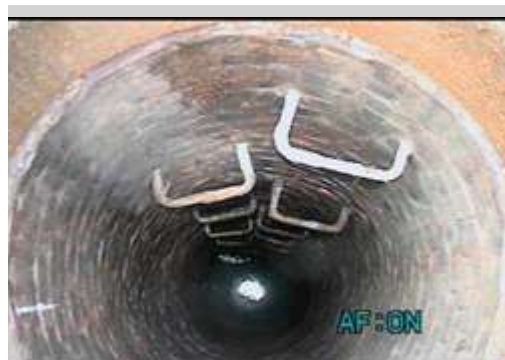
Defect 3

**Steps** Count: **18** Missing: **0** ☒ **Corroded**

corroded Steps

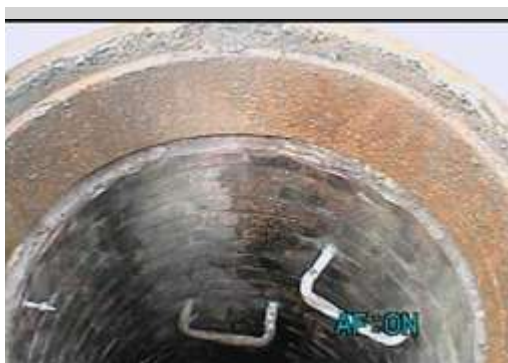
Defect 2

Condition: ☐ Sound ☐ Cracked ☐ Root Intrusion ☐ Loose Brick ☒ **Deteriorated**

Infiltration: ☐ None ☒ **Joint** ☐ Cracks ☐ Mortar ☐ Roots ☐ Wall

infiltration from chimney joint

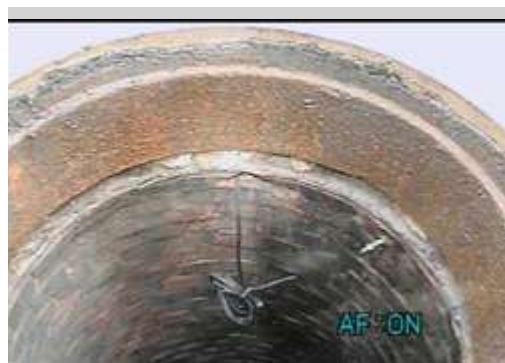
Defect 1

Frame Adjustment

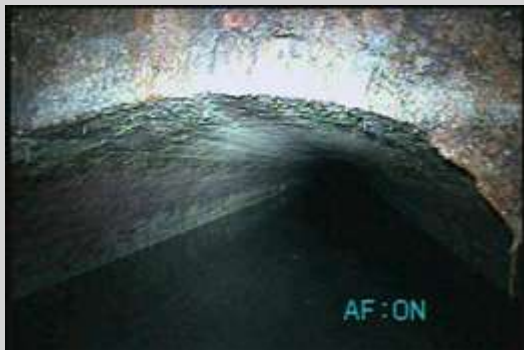
12 O'Clock Outflow

60 in. Circular Gravity Sewer  
Pipe Out @ 12 O'Clock

60" pipe, highest allowed in software = 42"

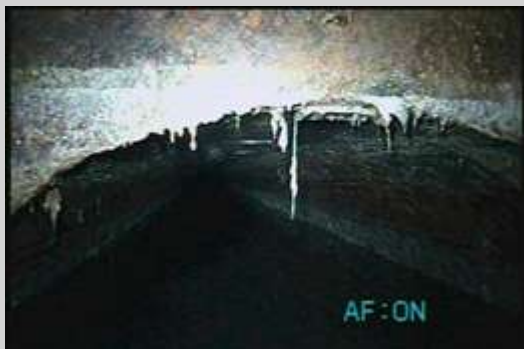
6 O'Clock Inflow

60 in. Circular Gravity Sewer  
Pipe In @ 6 O'Clock

60" pipe, highest allowed in software = 42"
